(RE)BUILT TO LAST

RETROFITTED FANS IMPROVE SYSTEM RELIABILITY & REDUCE COSTS FOR ELECTRIC POWER PLANT

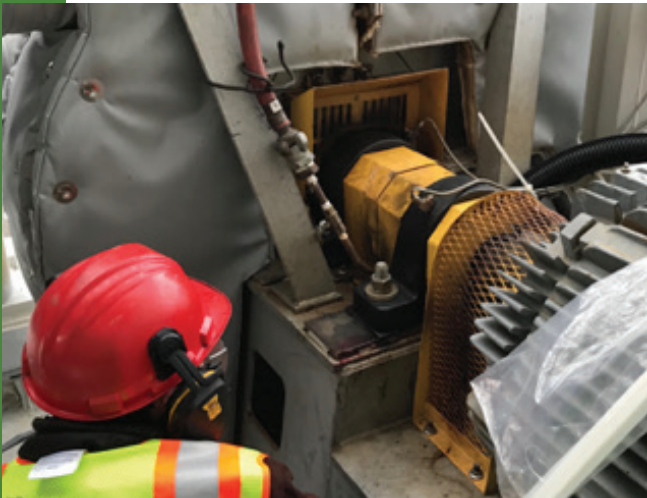
In one of the two systems, the fan bearings were experiencing excessive temperatures that led to premature wear, and the equipment required frequent repair and replacement. The customer had attempted to mitigate the problem by blowing compressed air into the space between the bearings. However, the customer needed a more permanent solution to increase system reliability and reduce the cost of frequent maintenance, replacement parts, and unplanned downtime.

An inspection is conducted by a technician to determine the cause of overheated bearings.

After a careful inspection of all four fans, the team identified two underlying factors contributing to the overheating problem. The primary cause was heat conduction due to the direct connection between the fan casing and the drive base, and a secondary cause was radiation from the exposed hot casing wall between the heat slinger guard and the insulation jacket.

- Separation between the casing and drive base to prevent the conduction of heat between the two.
- Modification of the cooling wheel and guard configuration to insulate the exposed hot casing wall and improve air circulation around the cooling wheel to keep the bearing area cool.
- Change the bearings to an oil lubricated, mono-block tunnel bearing arrangement for optimal alignment and robustness.
